# PERMANENT REPAIRS TO... GAS ENGINE COMPRESSOR.

**METAL LOCKING SERVICE inc**  
**MLS MACHINE SHOP**

# THE COMPLETED REPAIR...

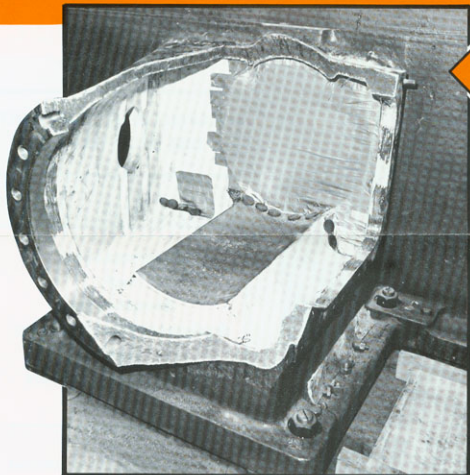
Accidental wedging of the crosshead, forced the top of the crosshead extension out. Since the crosshead guide is an integral part of the main frame, the options or repair are few. Re-attachment, particularly by use of heat (such as welding), would not only be inadequate for the strength required, but would present problems of alignment through distortion, which usually follows welding or brazing procedures.

These pictures show the damaged areas as we first saw them. The upper picture shows the crosshead guide with the upper half broken away.

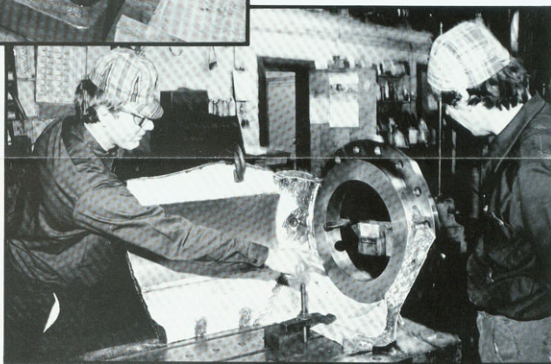
The lower picture here shows the broken section, in our shop, being prepared for re-attachment.
