CAST IRON
REPAIR

Metal Locking Service Quarterly Newsletter
Spring 2010 Edition

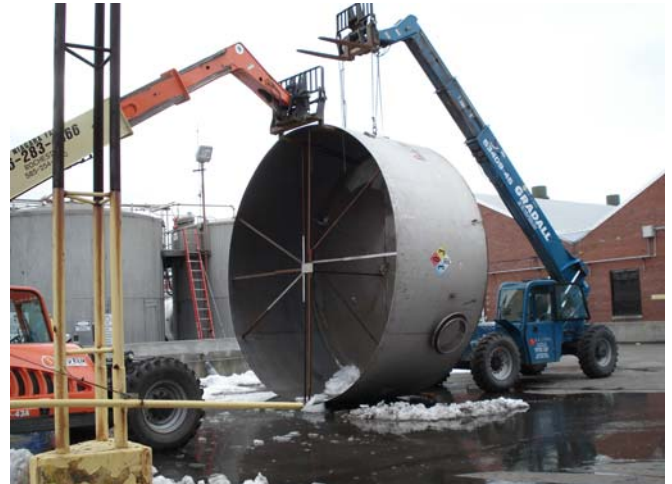
Featured Job – An international chemical company contracted MLS to disassemble a 25,000 gallon stainless steel storage tank located in West Virginia and relocate it to their Buffalo, NY location. The tank was plasma cut into manageable sections that were shipped to Buffalo where they were placed, pieced together, and welded. Safety is a priority on every job but this job had special considerations with the placement of the tank in close proximity to other chemical holding tanks.

On-site Tank Assembly at FMC

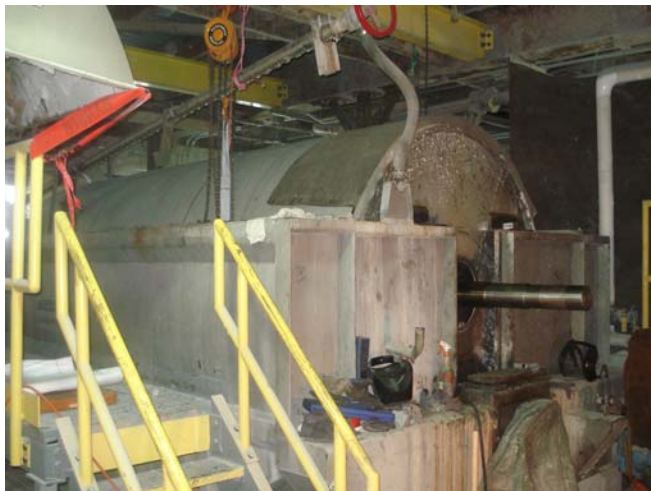
In-Situ Drive Shaft Repair in Glenn Falls, NY

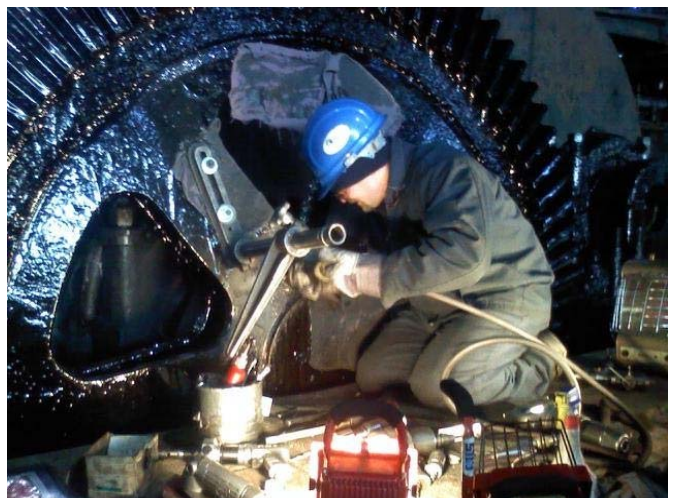
Dirty Work – The large gear pictured to the right is used in the processing of hot rolled steel bars. During a routine maintenance inspection, it was found to have one spoke had cracked almost completely through the cross section. MLS mobilized in a single day's time and was on-site the next. The gear was repaired at our customer's location in McDonald, OH via our metal locking technique. Our crew worked staggered shifts to help minimize the customers down time and lost production.

On-site Gear Repair in McDonald, OH
