# AND YOU THINK YOU'VE GOT FOOT PROBLEMS!

# TALK ABOUT FOOT PROBLEMS!

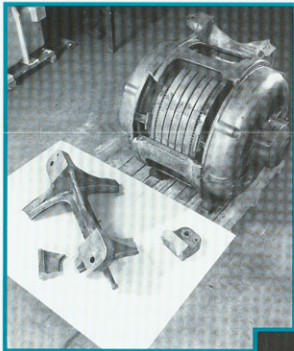
◀ 350 H.P. motor with three out of four of the mounting feet broken completely off.
