Metal Locking Service Inc.
MLS Machine Shop

Crosshead Guide Repair Proposal

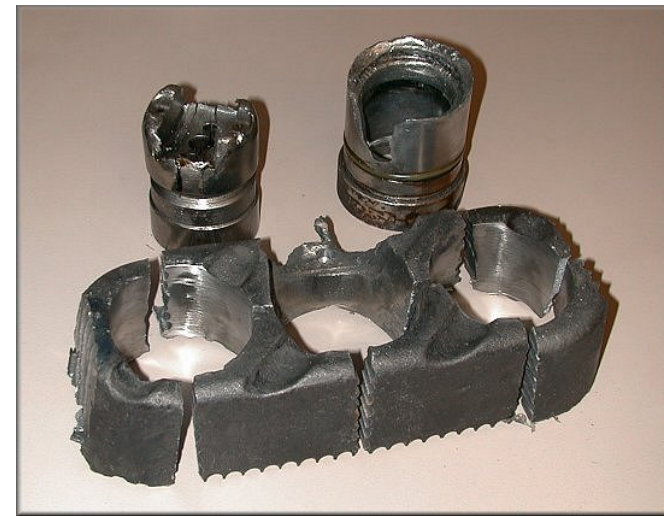
Damaged cam, aluminum liner, and crosshead guide (note center section)

When failure occurs, for whatever reason, in the crosshead guide area, it is our understanding that there are currently only two options:

- **Option 1**
Repairing the damage by inserting and welding a steel liner in the affected bores.
- **Option 2**
Scrapping of the engine frame.

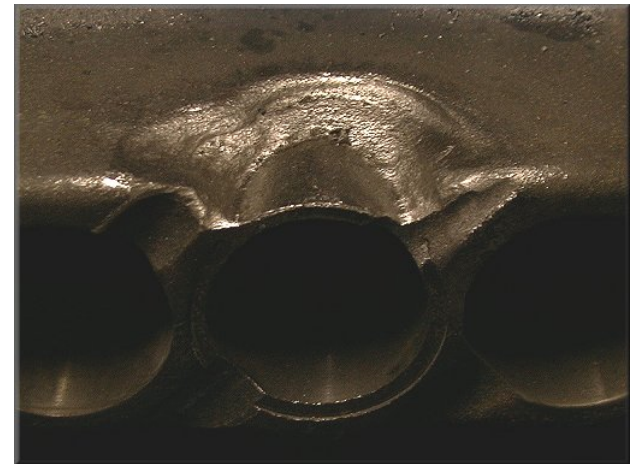
Close up of the damaged bore with the inserted steel liner yet to be welded

- **Option 1 (Lining the bore with a steel sleeve and welding)**

We feel that a mechanical repair is better suited than welding for two primary reasons:

- 1) **The integrity of the casting has been compromised.**
 - a) The broken area is being replaced with a steel liner.
 - b) Stresses are being imposed on the casting, due to welding, which are prohibitive to longevity.
 - c) The liner is shouldering the burden of strength.
- 2) **Aluminum and steel liners possess different characteristics.**
 - a) Thermal expansion rates differ
 - b) Heat transmission rates differ
 - c) Possible differences in lubrication qualities

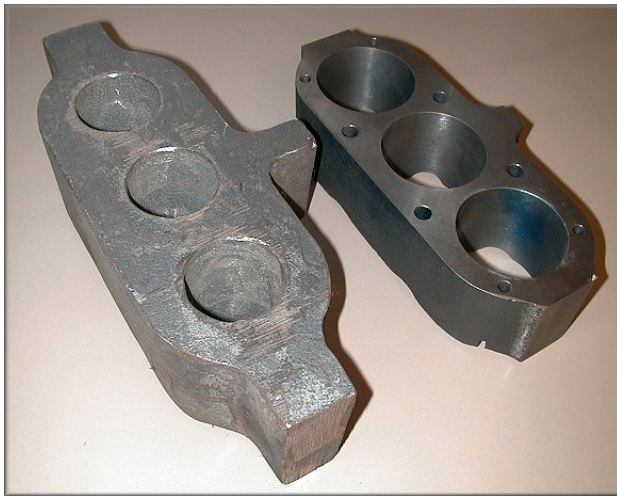
Rough casting (left side) and finish machined casting (right side)

- Requisitioning a Grade 40 casting
 - Local order for quick turnarounds
- Machining to developed specifications
 - Finish bores to size
 - Facing of the mating surface
 - Location and drilling of the bolt pattern
 - Facing the attachment ribs

We keep a minimum of two completely machined castings at our facility at all times.

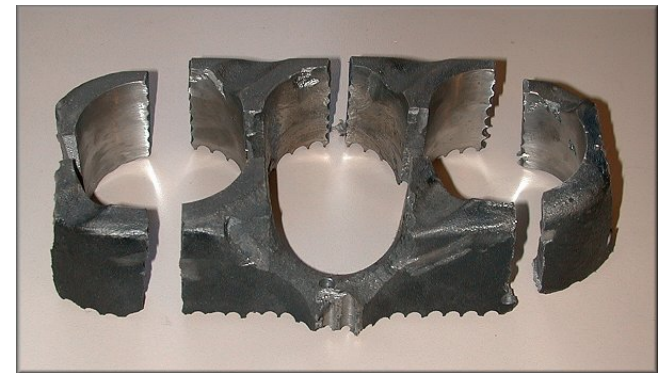
- Dye penetrant/magnaflux is used for determining the extent of the damage.
- Drilling and ripping away the damaged material is done in sections.
- Machining the mating surface.

Damaged casting removed via drilling along a plane and removing with an air chisel

A cutter is located on each individual bore for machining purposes.

The ribs are hand fit to mate with the replacement casting.

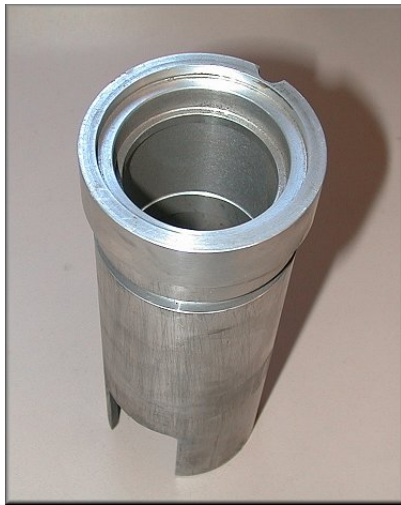
Typical Aluminum Liner
used for alignment

- Two aluminum liners are inserted in the outside bores for aligning the replacement casting.
- A powdered developer is used for lapping the mating surfaces.
- The replacement casting is clamped in place.
- The replacement casting is used as a guide for drilling and tapping the head and face bolts.

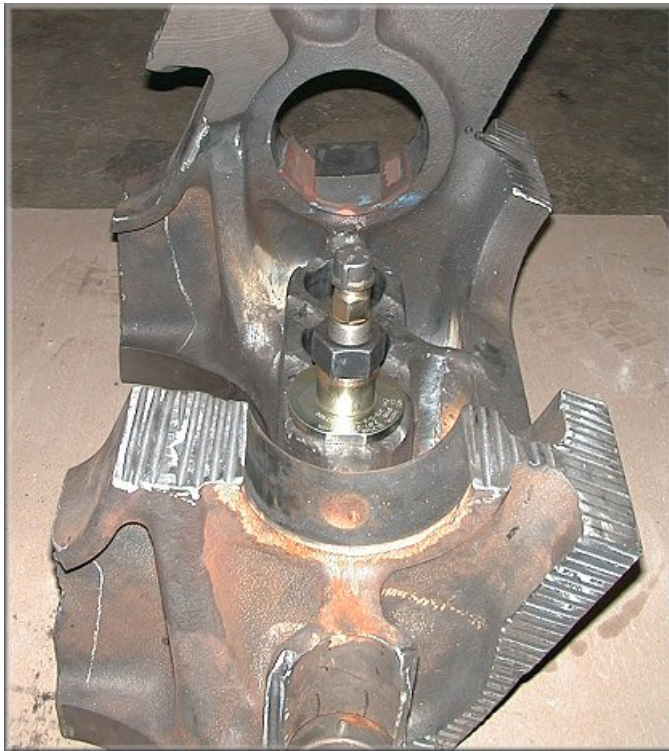
The portable prototype

To test the feasibility of our procedure, we performed a mock repair on a scrap frame in our shop.

This prototype repair has enabled us to:

- Test a wide array of components.
- Prove our procedure.
- Prove our testing device.
- Provide a portable model for scrutiny.

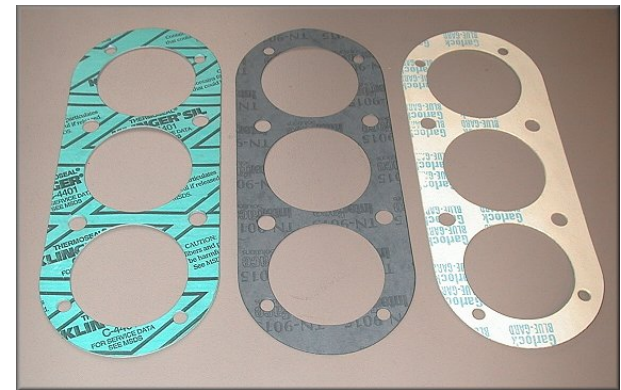
- a. Material choice (Klinger-Thermoseal, Garlock-Blueguard, Interface-TN and pure Graphite).
- b. Thickness.
- c. Sealing characteristics.
- d. Durability through the repair.

Various gaskets that we tested

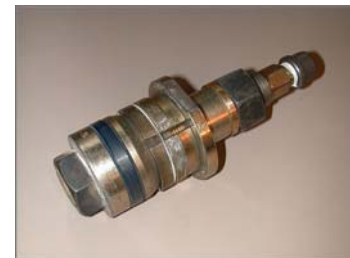
- a. Function.
- b. Portability.

Testing device (1 of 6)

To prove both the gasket and the testing device, we subjected them to a series of hydrostatic tests.

- Maintainable pressures in excess of 300psi (more than 200% above the maximum operating pressure of 120psi).
- The portability and function of the testing device.
