CAST IRON
REPAIR

ON-SITE MACHINING
SOLUTIONS

Metal Locking Service Quarterly Newsletter
Winter 2006 edition

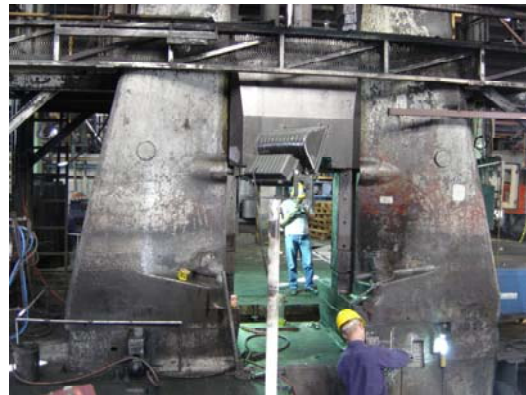
Current Projects - Language barrier - No Problema! This recent job (below) was completed in Toluca, Mexico. Our customer, an automotive component manufacturer, called us when their 16,000 metric ton Forging Hammer cracked its anvil base. We completed the repair within budget and 12 hours ahead of our promised deadline. Our 4-man crew worked around-the-clock and per the customer "did an excellent job!"

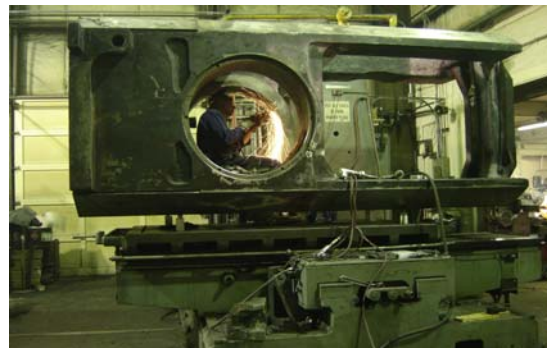
After a customers failed attempt to weld and stress-relieve their forging press (see below), we were called in. Our customer agreed that our mechanical repair (no welding or heat application) offered the best solution. The 35,000lb ram was shipped to our Buffalo, NY shop for an in-house repair while the press frame is being repaired on-site.
