CITY OF BUFFALO  
FIREBOAT

EDWARD M. COTTER

V-12 - 397 CATERPILLAR ENGINE

# REPAIR - AS STRONG AS NEW!

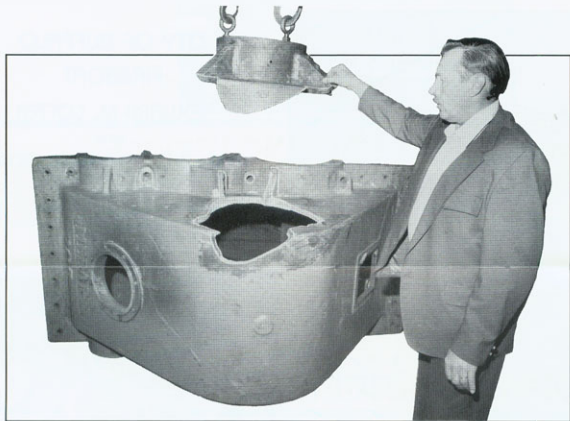
THE RESULT OF A BROKEN SHAFT IN A CAST IRON GEAR CASE  
FROM A BAR STRAIGHTENER FOR A PROMINENT STEEL COMPANY.

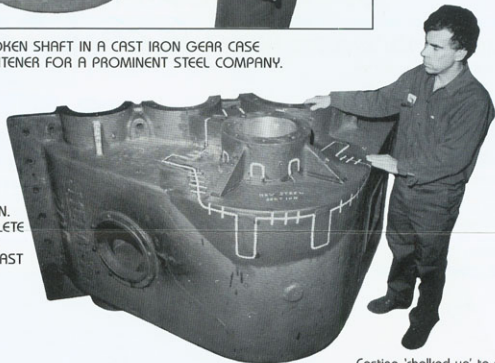
Casting 'chalked up' to show  
area of repair. Actual  
repairs are difficult to detect.

STEEL SECTION  
LOCKED AND LACED INTO POSITION.  
FINAL BORING RESULTED IN COMPLETE  
RE-ALIGNMENT WITH COMPANION  
BORES. PLACEMENT OF STEEL IN CAST  
IRON EFFECTS AS
